MICHIGAN DEPARTMENT OF TRANSPORTATION

STR 8251

BRIDGE SAFETY INSPECTION REPORT

BALL ST	42.8552 / -83.4478	635505000003B01	Good Condition(8)	
Feature	Length / Width / Spans	Owner		
KEARSLEY CREEK	38 / 31.8 / 1	City: ORTONVILLE(5050)		
Location	Built / Recon. / Paint / Ovly.	TSC	Operational Status	
IN ORTONVILLE	2014 / / /	Oakland(23)	A Open, no restriction(A)	
Region / County	Material / Design	Last NBI Inspection	Scour Evaluation	
Metro(7) / Oakland(63)	5 Prestressed Concrete / 05 Box Bm/Gird- Multiple	09/28/2017 / QBVA	5 Stable w/in footing

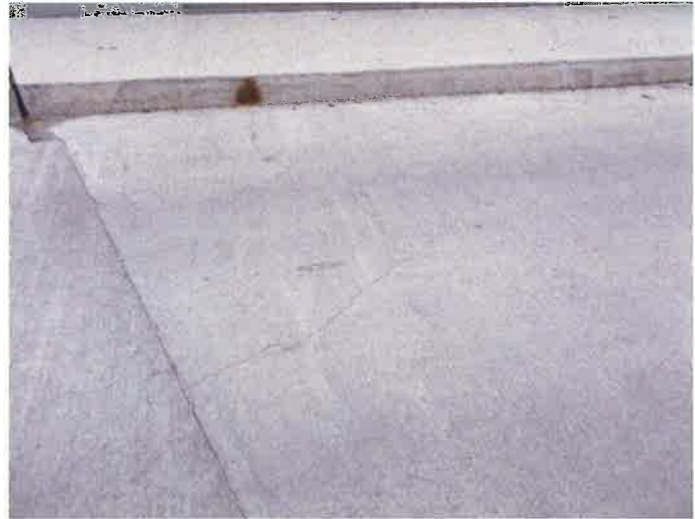
1. Surface (SIA-58A)	8	8	7	Concrete deck. E ref line: 4 diagonal cracks, 2 longitudinal cracks. W ref line: 5 diagonal cracks, 1 longitudinal crack. Minor edge debris noted. (09/17) Concrete deck. Diagonal cracks propagating from each reference line. Minor edge debris noted. (09/15) New tined concrete composite deck. Isolated minor diagonal crack noted in southeast propagating from reference line. Minor edge debris noted. (12/14)

Document Name: DSCN0416.JPG
 Category: Deck
 Comments: Diagonal cracks
